IN RE: ETHICON, INC.,

PELVIC REPAIR SYSTEM PRODUCTS

Master File No. 2:12-MD-02327 MDL 2327

Intentional Oxidation of Prolene Mesh Supplemental Report of Dr. Shelby F. Thames August 8, 2016

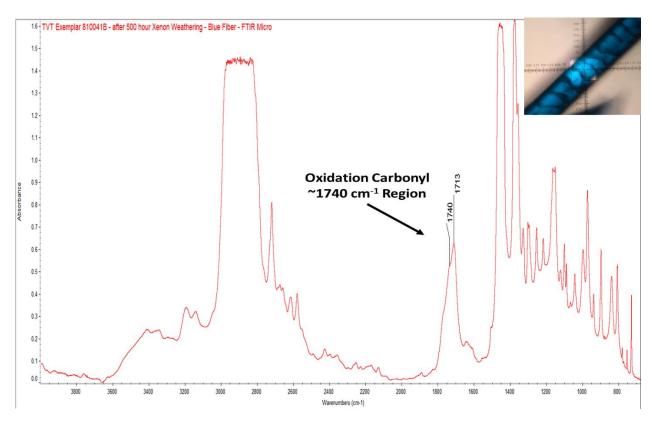
Figure 7. TVT Exemplar 810041B - After 500 hrs. Xenon Exposure - Blue Fiber

At 500 hrs. UV exposure the TVT exemplar was removed from the exposure chamber and again characterized via FTIR Microscopy (Figure 7). Oxidative degradation is noted as evidenced by the presence of strong carbonyl absorption frequencies in the ~1740 cm⁻¹ to 1713 cm⁻¹ region accompanied by extensive fiber cracking.

SEM, or light microscopy examinations. In these cases, carbonyl absorption frequencies, known to accompany oxidized Prolene (see Figure 7) were not present, and thus *in vivo* oxidation did not occur.

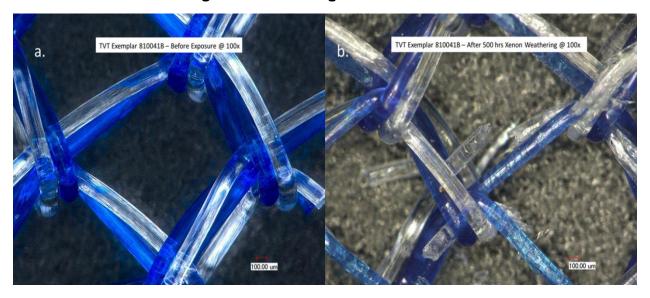
Figure 11. Light Microscopy of TVT 810041B Exemplar before UV exposure (a.) and after 500 hrs. UV exposure (b.)

Digital microscopy and scanning electron microscopy (SEM) of the before and after fiber exposure samples were conducted with a Keyence VHX-600 digital microscope (Figure 9) and a Zeiss Sigma VP FEG-SEM (Figure 10). One can readily observe the oxidation effects upon Prolene as demonstrated by light microscopy and SEM images (Figures 11 and 12) of fibers; before and after UV exposure. As a result of UV exposure as described herein, Prolene fibers were grossly embrittled and demonstrated deep cracks resulting in fiber rupture via crack propagation.

Note the extensive fiber cracking and flaking: the product of crack propagation. Clearly the physical properties of Prolene have been severely compromised by UV light exposure (i.e. oxidative degradation).
